C U L T U R A L L A N D S C A P E R E P O R T

Harry S Truman National Historic Site Independence, Missouri

APPENDIX

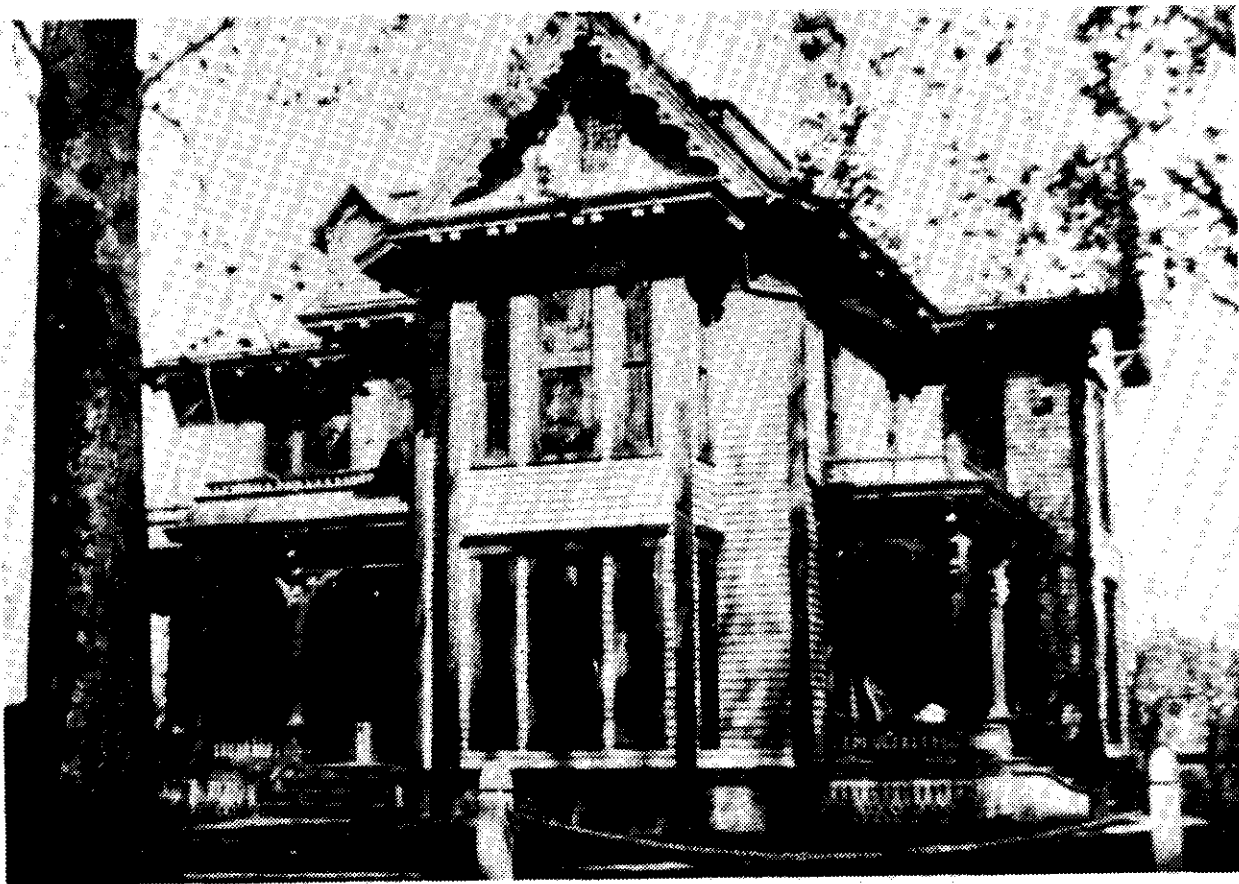
FIGURE 1

Gates house (west facade)

Important landscape features: no shrubbery adjacent to foundation;
decorative post and rope fence; and large tree to south of front
walkway.

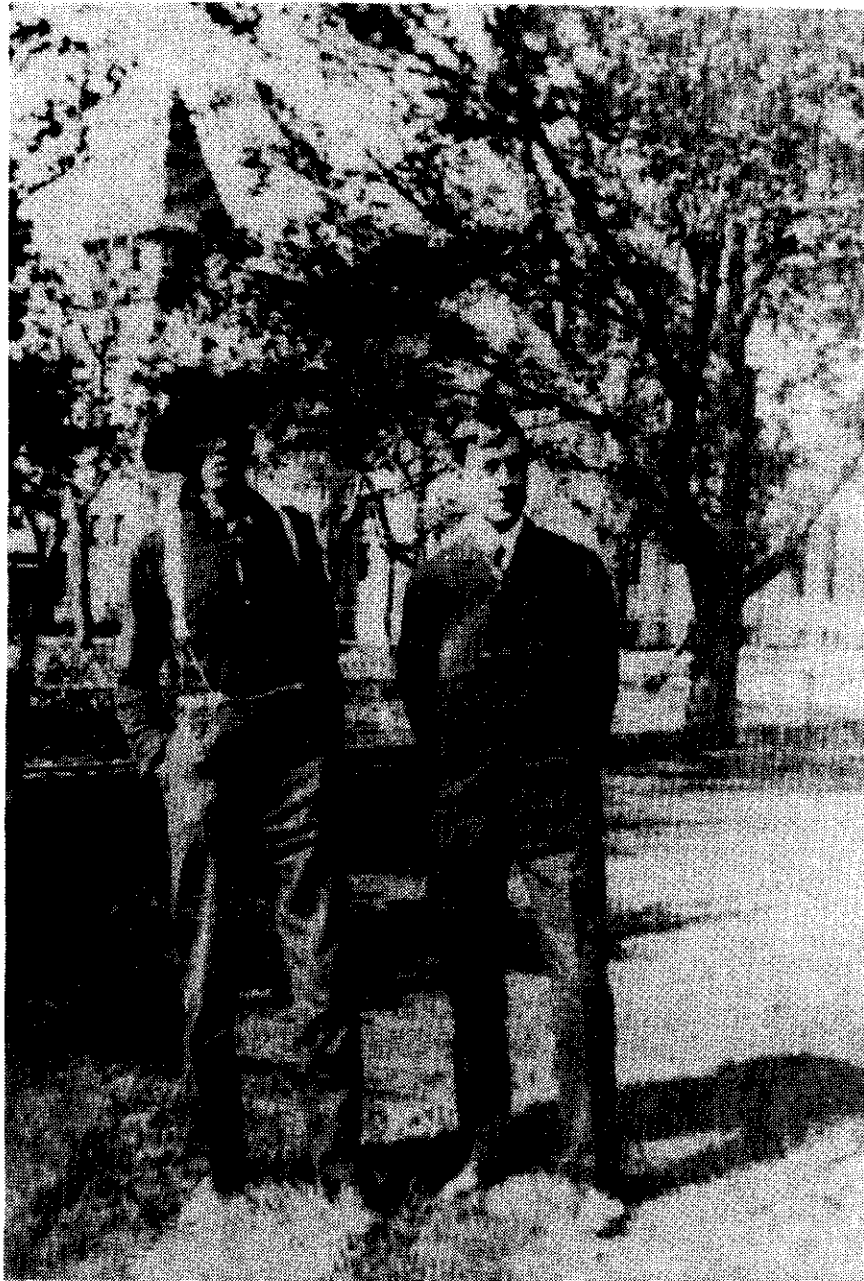
FIGURE 2

Frank Wallace (left) and unidentified man in the Gates/Wallace's southwest yard (looking southwest).

Important landscape features: no shrubbery adjacent to the alley; small decorative metal fence paralleling the alley; and moderate-sized tree in the yard's southwest corner. (Methodist Church is in background).

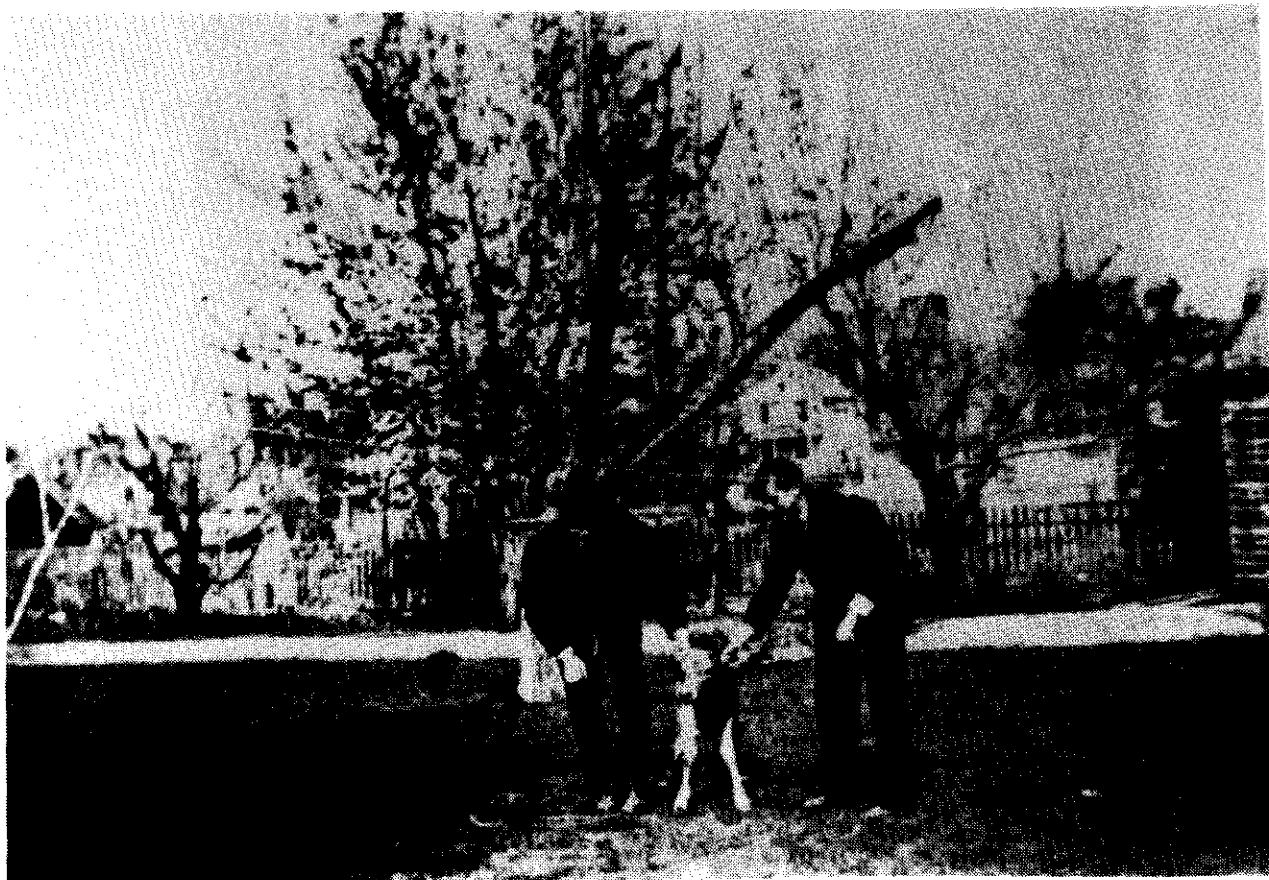
FIGURE 3

Frank Wallace (left) and unidentified man with a calf in the Gates/Wallace back, east yard (looking east).

Important landscape features: at least four small trees surrounding the gravel driveway; picket fence separating Gates garden from lawn; and tall lattice fence (extreme right) near barn.

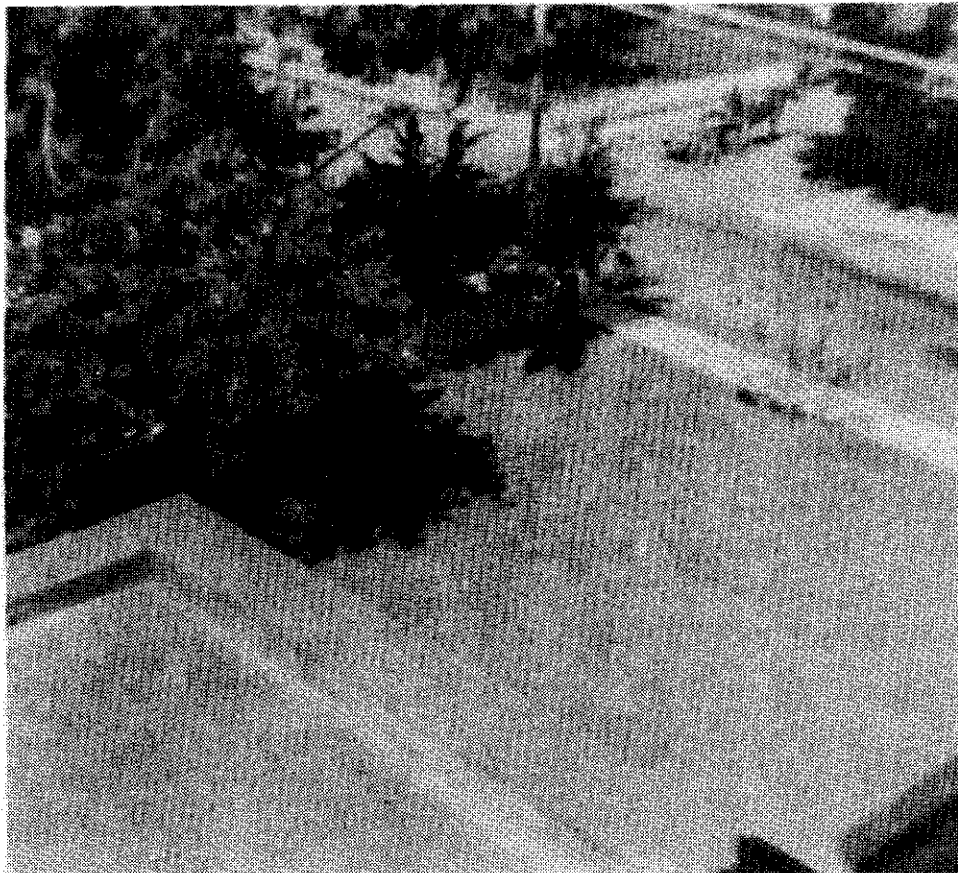
FIGURE 4

View of the northwest lawn from an upstairs window of the Gates/Wallace house (looking northwest).

Important landscape features: open lawn expanse; trees aligned in front yard along North Delaware Street; newly planted tree along West Van Horn Road and narrow sidewalk; and utility lines along the north lawn. (In foreground is rooftop of porch)

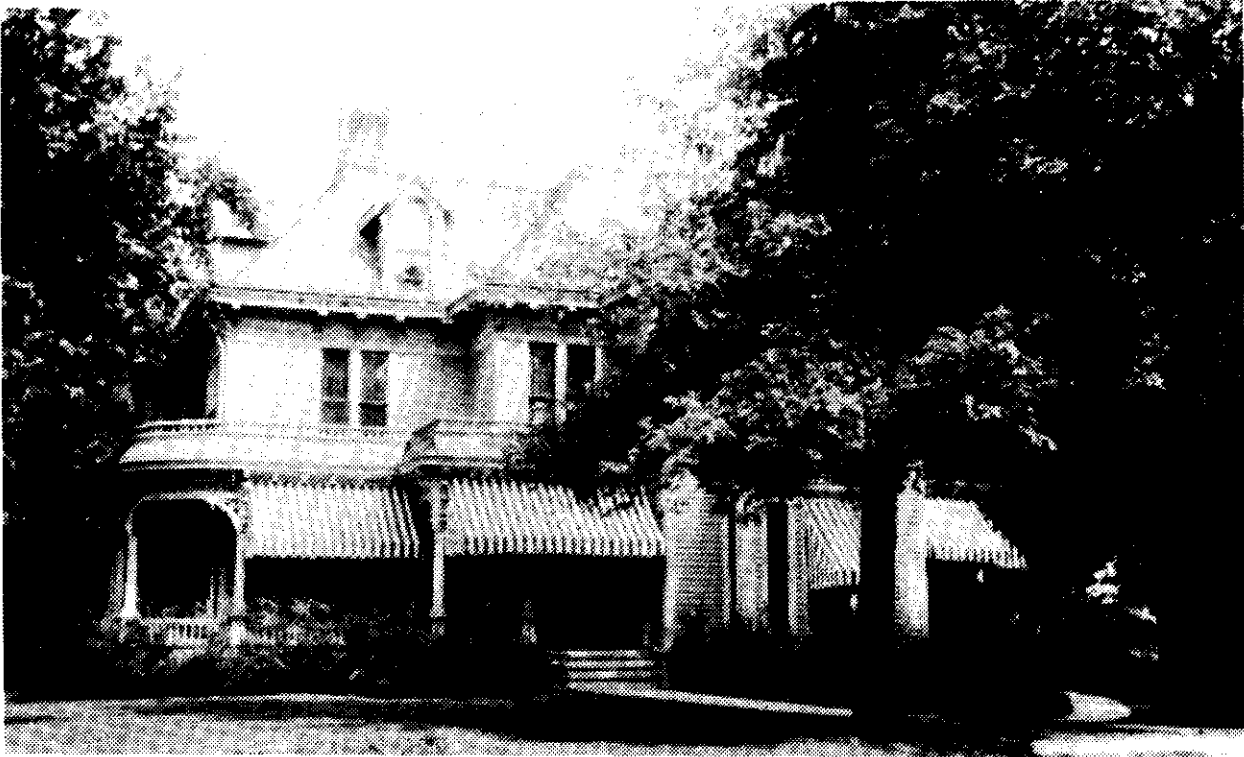
FIGURE 6

Gates/Wallace house and front, west lawn (looking east).

Important landscape features: dense spirea shrubbery encompassing the front facade; sidewalks; and trees.

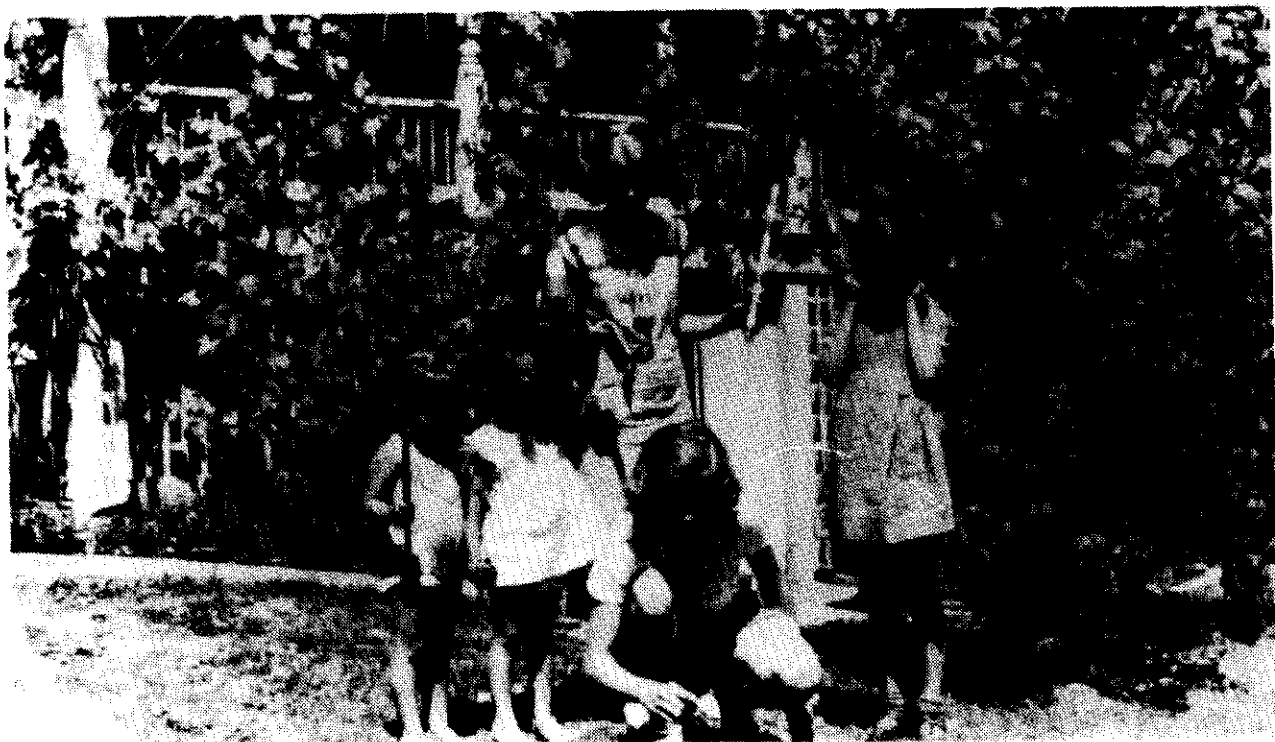
FIGURE 7

Margaret Truman and four friends in front of the south side rear porch.

Important landscape features: grapevines growing up onto the porch; weeds in the small planting bed between the sidewalk and latticework; tall bush to the right; and poor condition of the lawn.

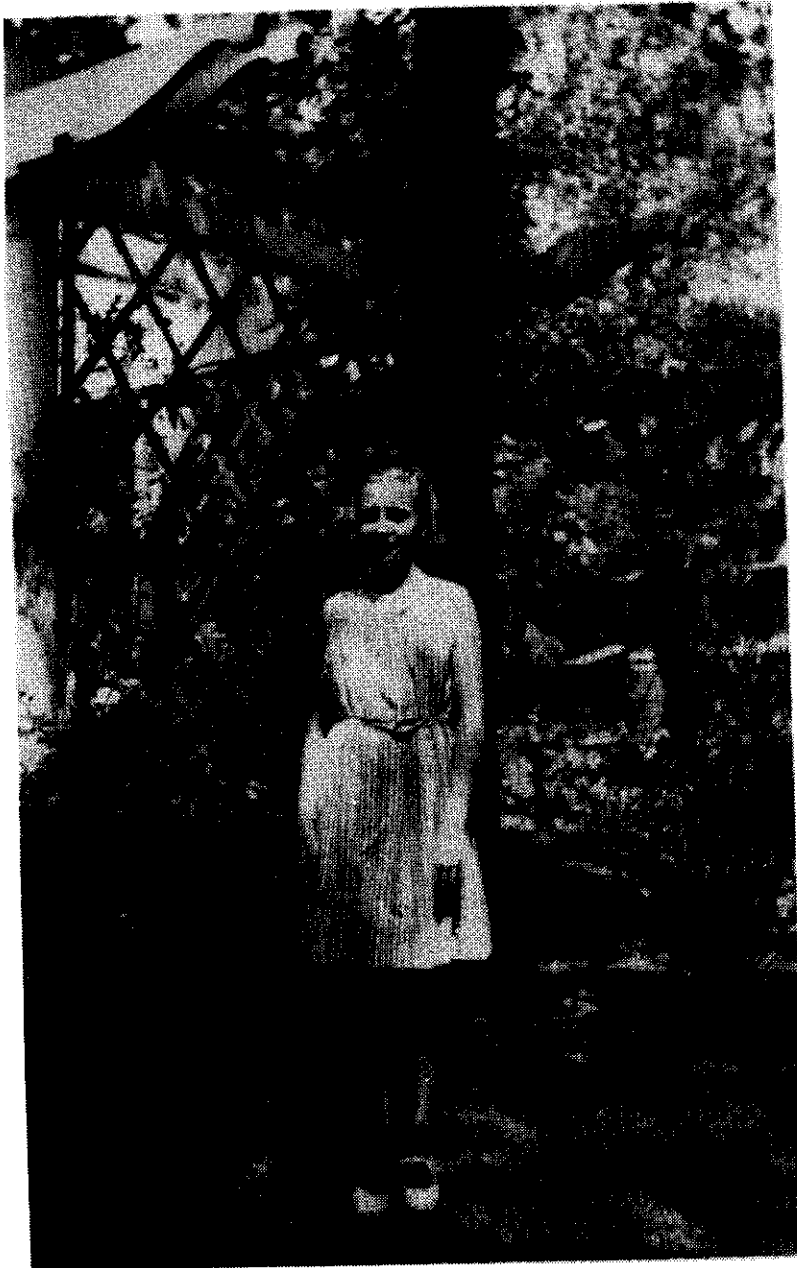
FIGURE 8

Margaret Truman at east end of pergola (looking northwest).

Important landscape features: climbing rose vines on the pergola;
elm tree; sundial in northeast yard; and low shrubbery in area.

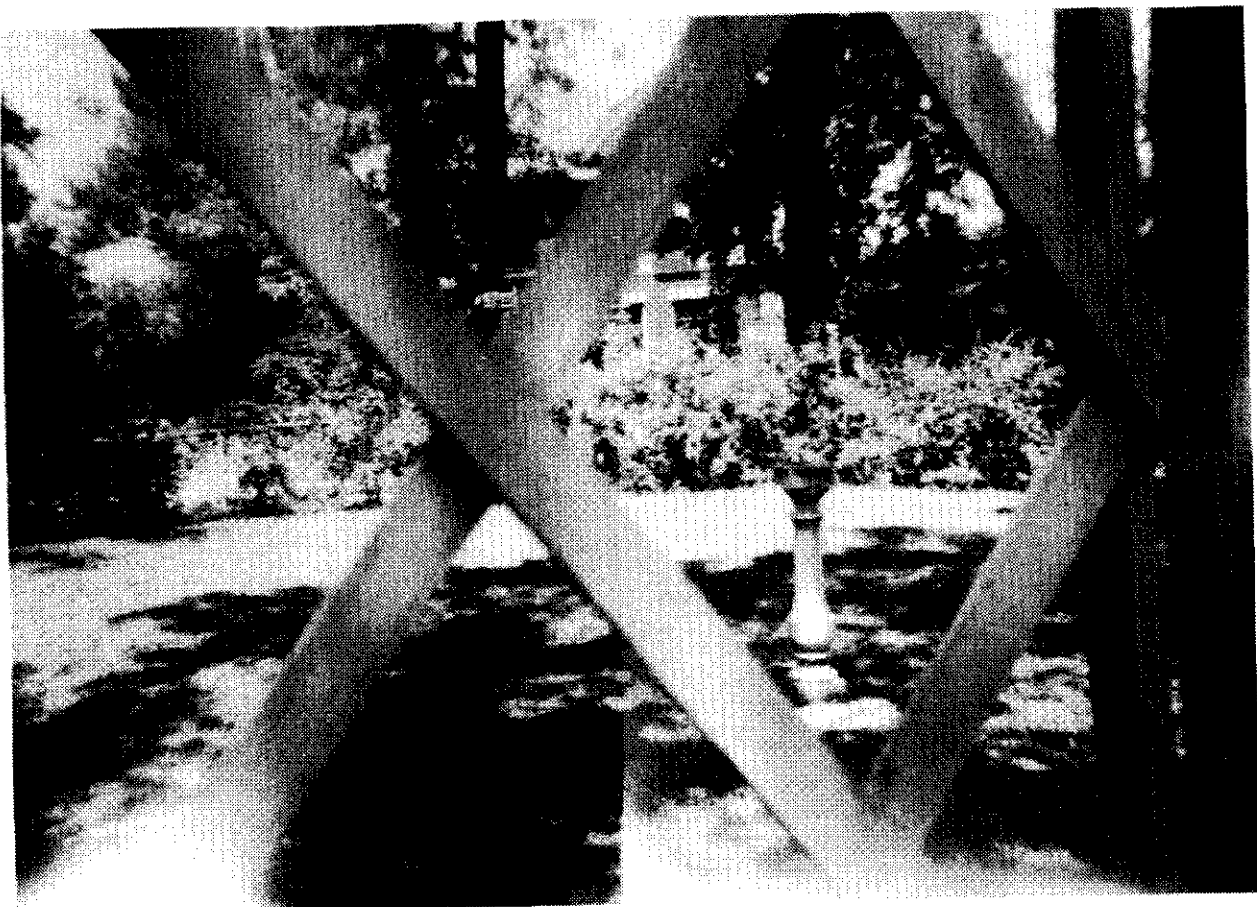
FIGURE 9

The northeast Wallace/Truman yard as seen from inside the pergola (looking north).

Important landscape features: sundial and paving stone; expanse of open lawn; decorative wooden fence and line of shrubbery paralleling West Van Horn Road.

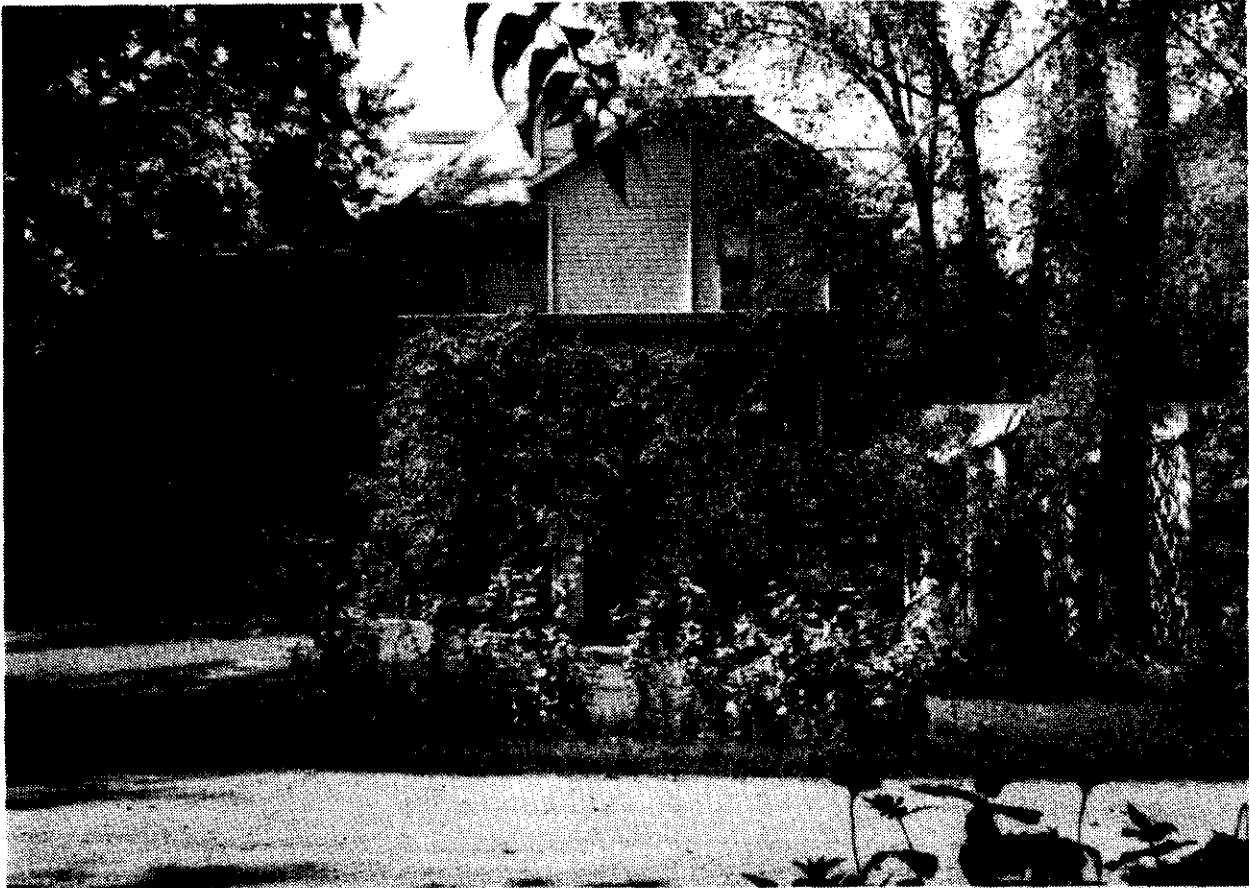
FIGURE 10

Wallace/Truman home and back, east yard (looking west).

Important landscape features: large elm trees on west and east ends of pergola; flowers in immediate foreground, east of gravel driveway; small rose garden; paving stone walkway; large bushes obscuring the back porch; and the large cluster of spirea and tree in "L" of house.

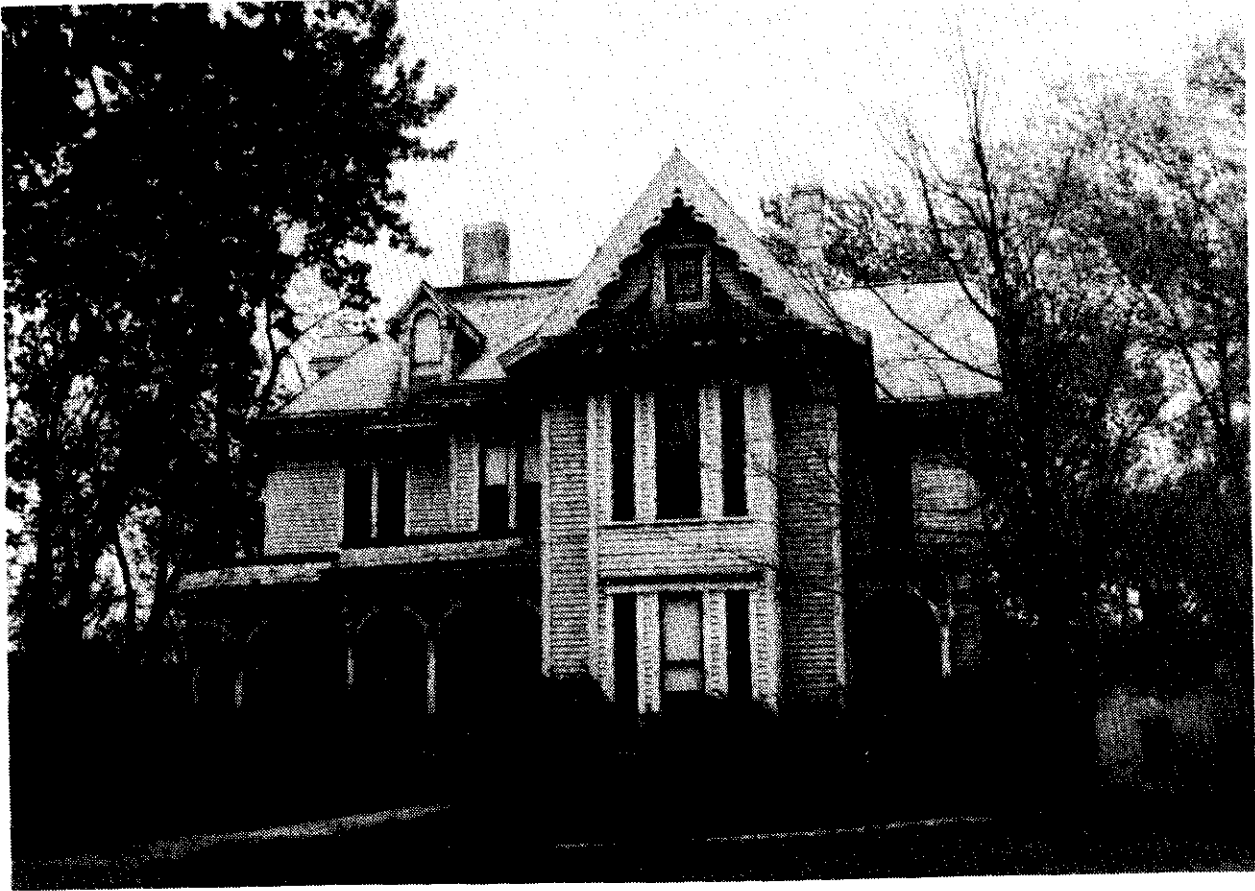
FIGURE 12

Wallace/Truman home and front, west yard.

Important landscape features: wild spirea encompassing west facade; shaggy growth of lawn; trees; sparse shrubbery near barn; and small doghouse at extreme right.

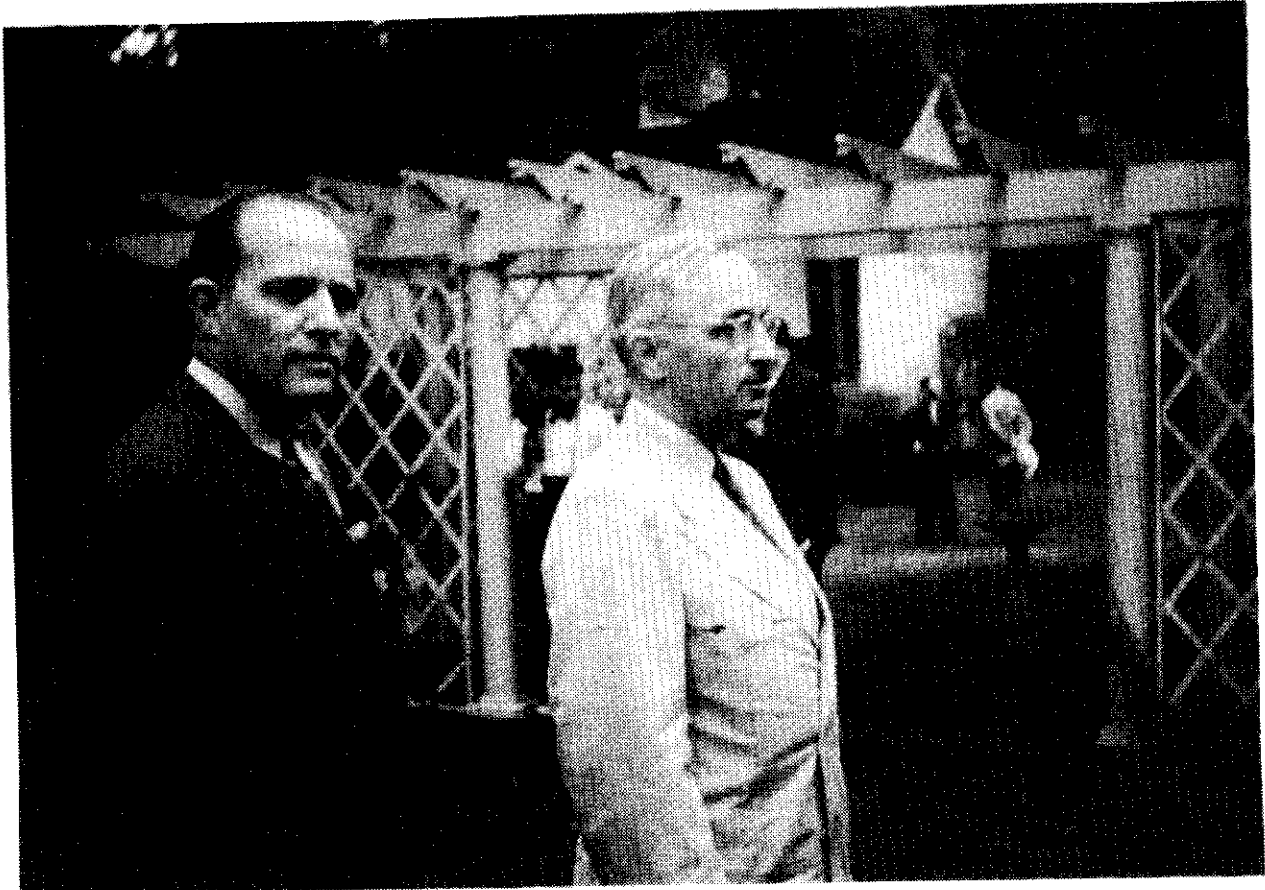
FIGURE 13

President Truman, reporters, and Secret Service agents in the back, east yard of the Wallace/Truman home (looking southeast).

Important landscape features: no plantings inside the pergola; small birdbath; and tree and shrubbery near the barn.

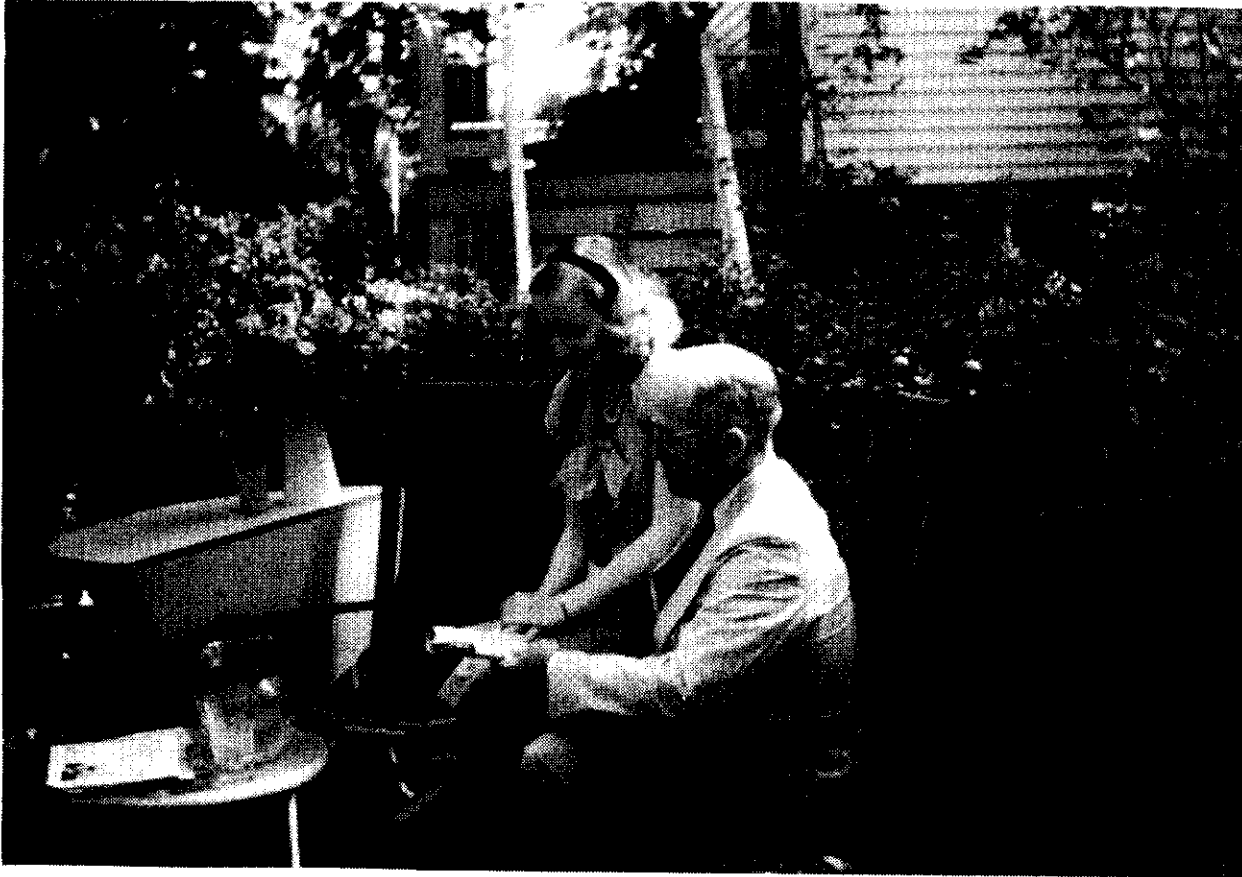
FIGURE 14

Margaret Truman and President Harry S Truman in the northeast yard (looking south).

Important landscape features: circle of bushes cutting off access to back porch, large bush along north wall of kitchen; and sparse ground cover.

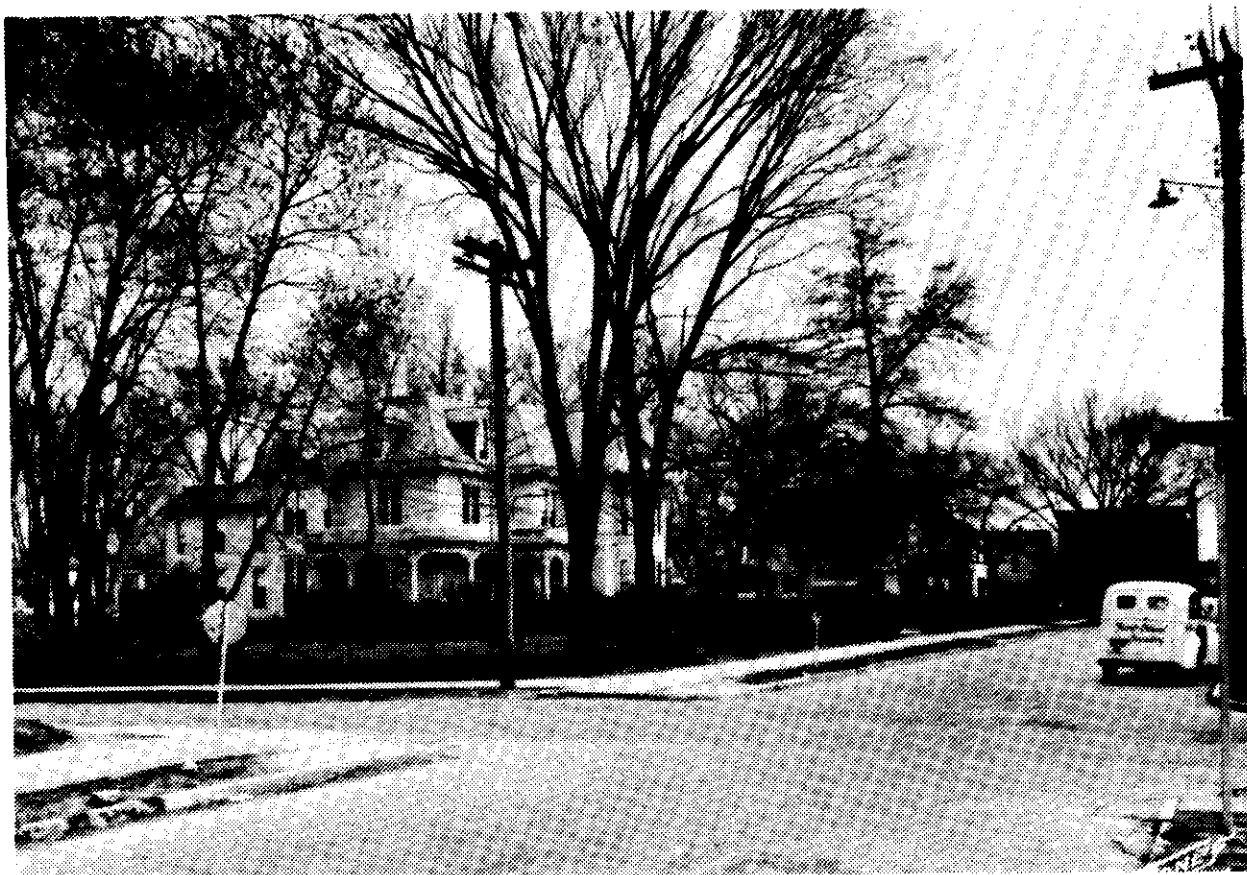
FIGURE 15

Wallace/Truman home at the corner of North Delaware Street and West Van Horn Road (looking southeast).

Important landscape features: steel picket fence; flagpole; wild spirea encompassing west facade; utility lines; placement of trees; large bush by back porch stairway; "no parking" signs; and shrubbery along alley fence.

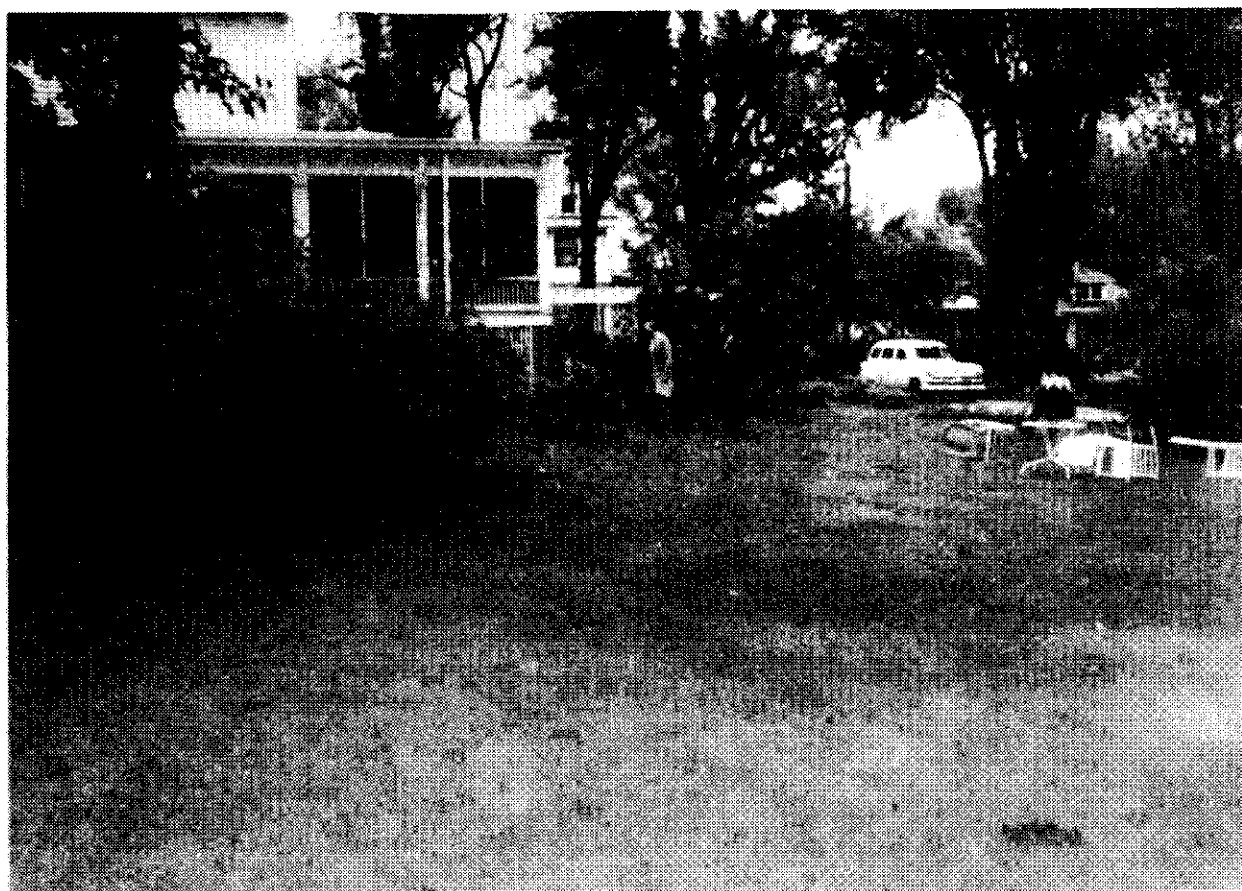
FIGURE 16

Southeast lawn of Wallace/Truman home (looking northeast).

Important landscape features: extension of back porch; open expanse of southeast lawn; placement of umbrella table and chairs; grapevine (cut back because of construction); and wild spirea growth surrounding the tree in the "L" of the house.

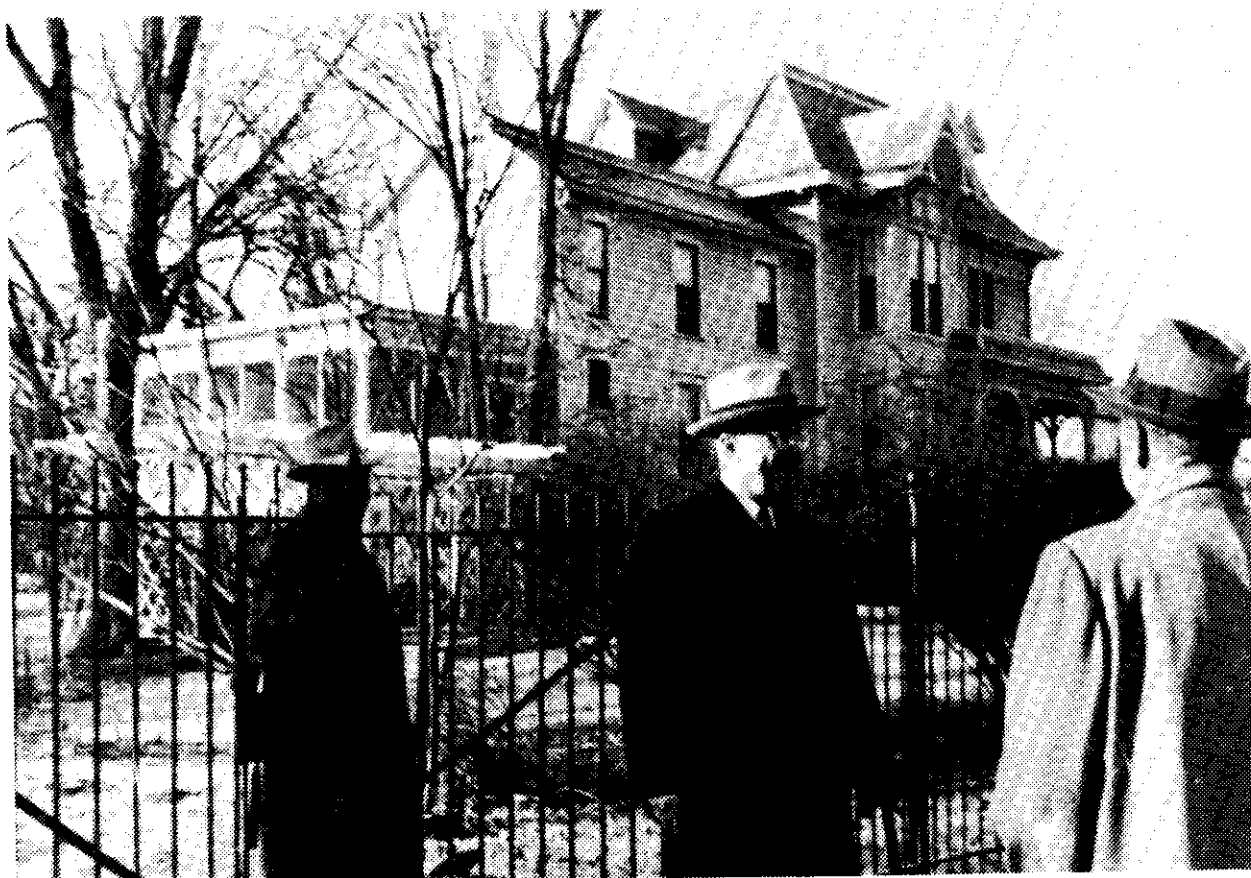
FIGURE 17

Former President Truman emerging from the Truman Road gate for a morning walk (Looking southwest).

Important landscape features: vegetation in pergola area and tall bushes along the Truman Road fence.

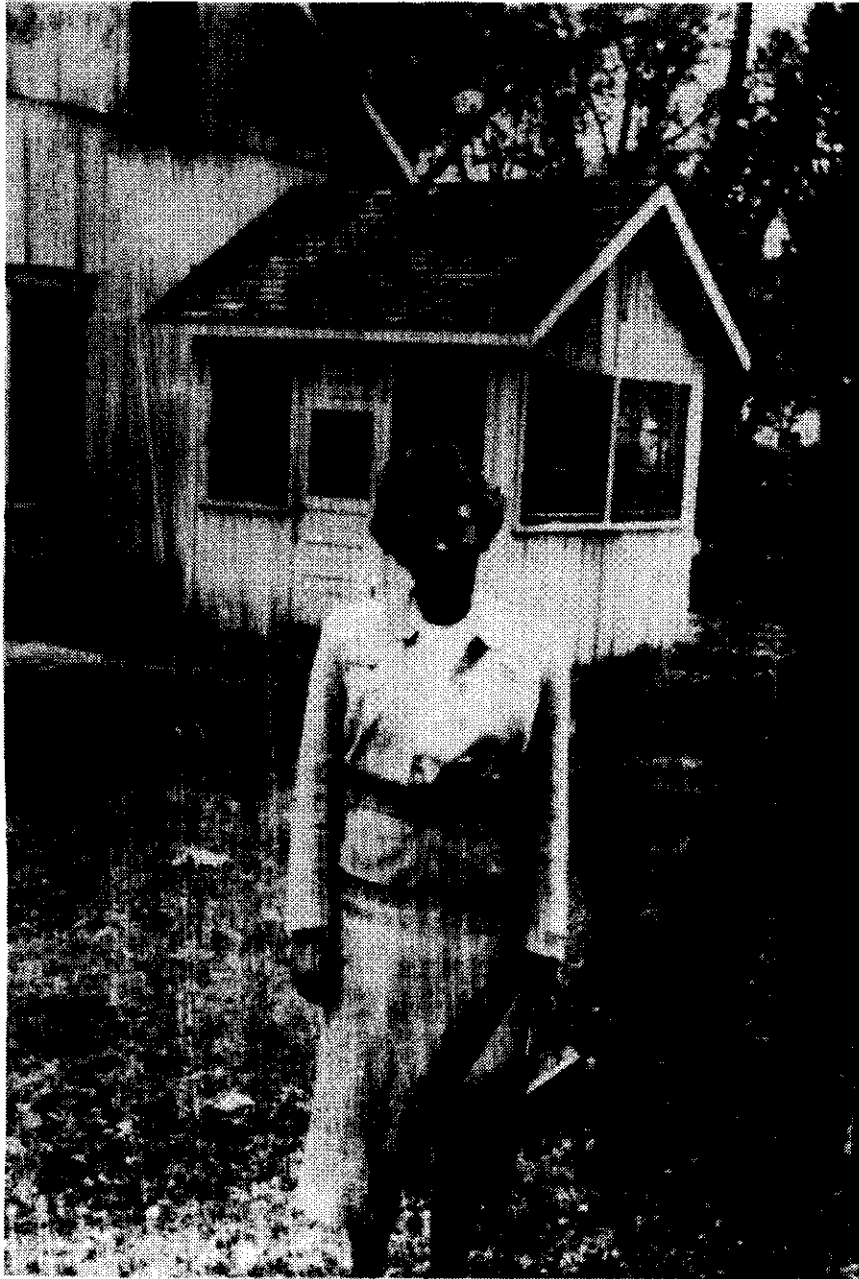
FIGURE 18

Mary Shaw standing in front of the barn and abandoned Secret Service Security Booth in the southeast yard of the Truman home (looking southeast).

Important landscape features: abandoned Secret Service Security Booth; tree growing between the small booth and the barn; and the general lack of vegetation in the area.

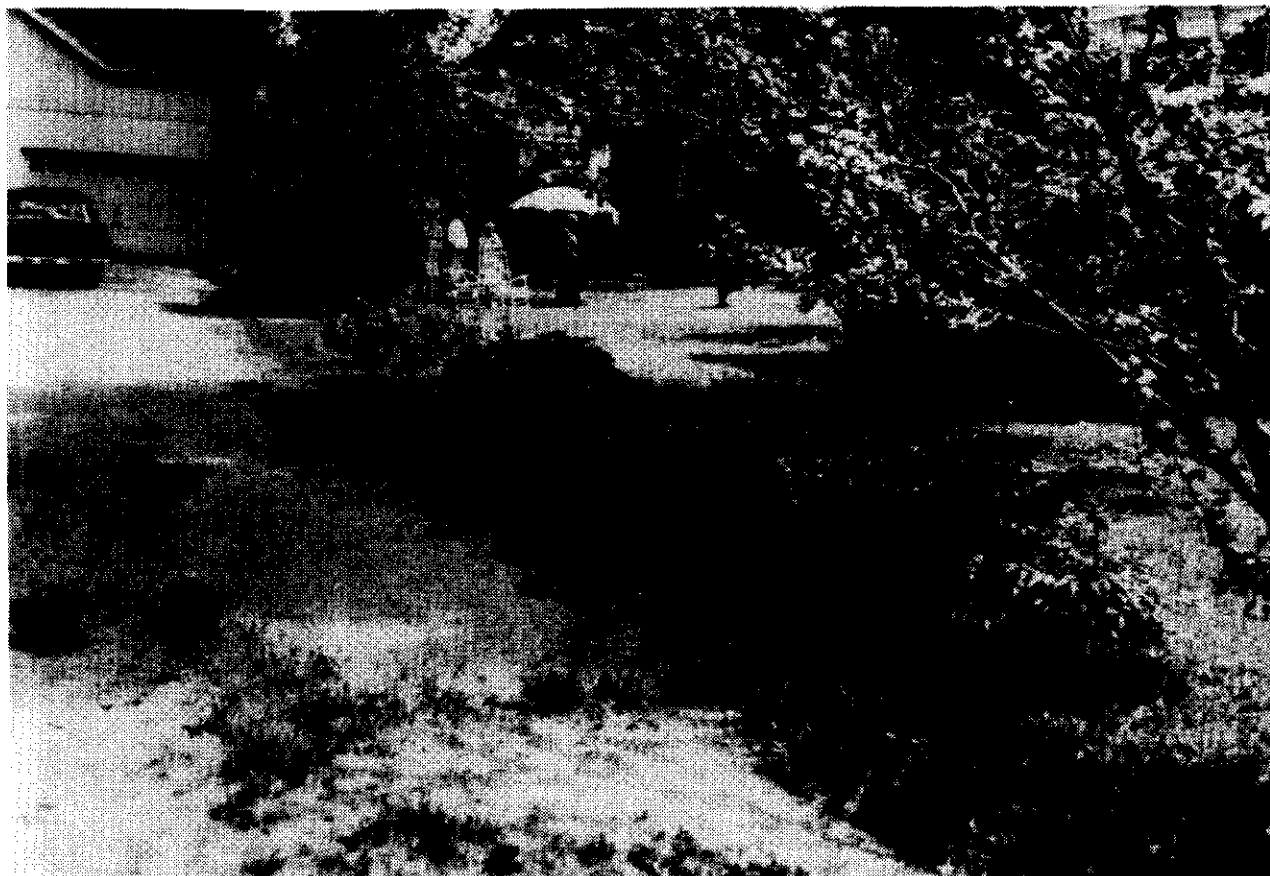
FIGURE 19

Truman/Wallace family making preparations for the Truman/Daniel wedding reception on the southeast lawn (looking south).

Important landscape features: uneven edge of gravel driveway; line of peonies; rose garden; tall bush and tree by the barn; and placement of lawn furniture.

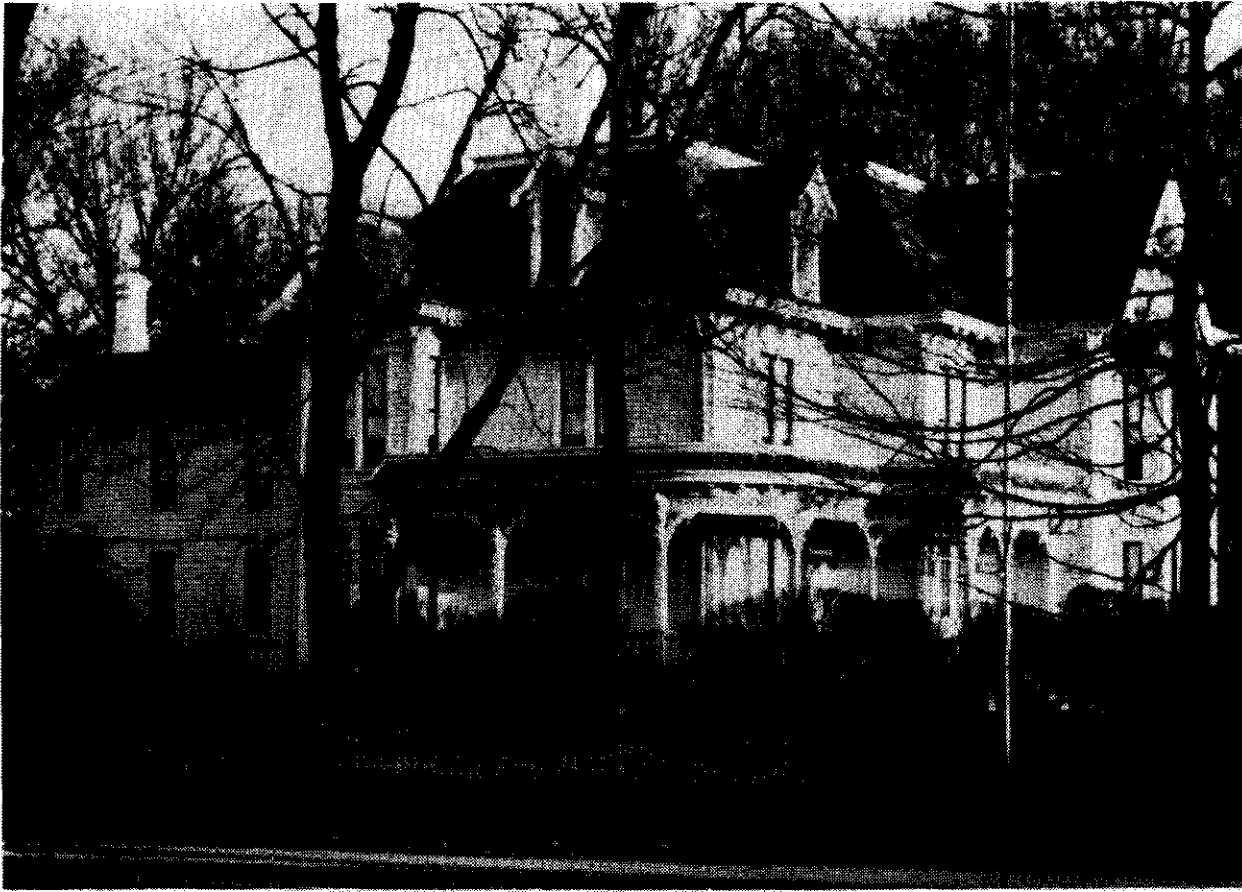
FIGURE 20

North lawn of Truman home (looking southeast)

Important landscape features: Shape and condition of spirea shrubbery; height of shrubbery near back porch; placement of trees; and flagpole.

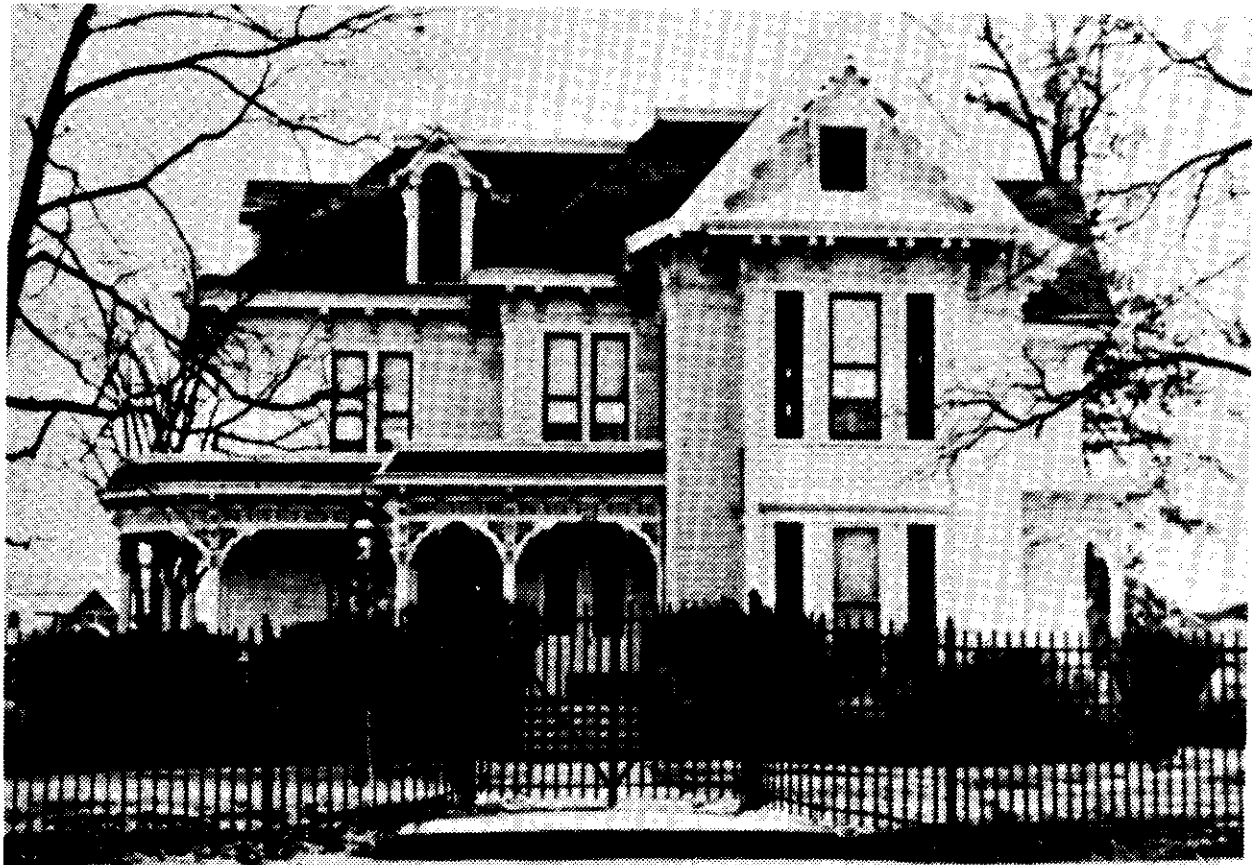
FIGURE 21

Truman home and west yard (looking east).

Important landscape features: gas lamp; condition and shape of spirea; and trees.

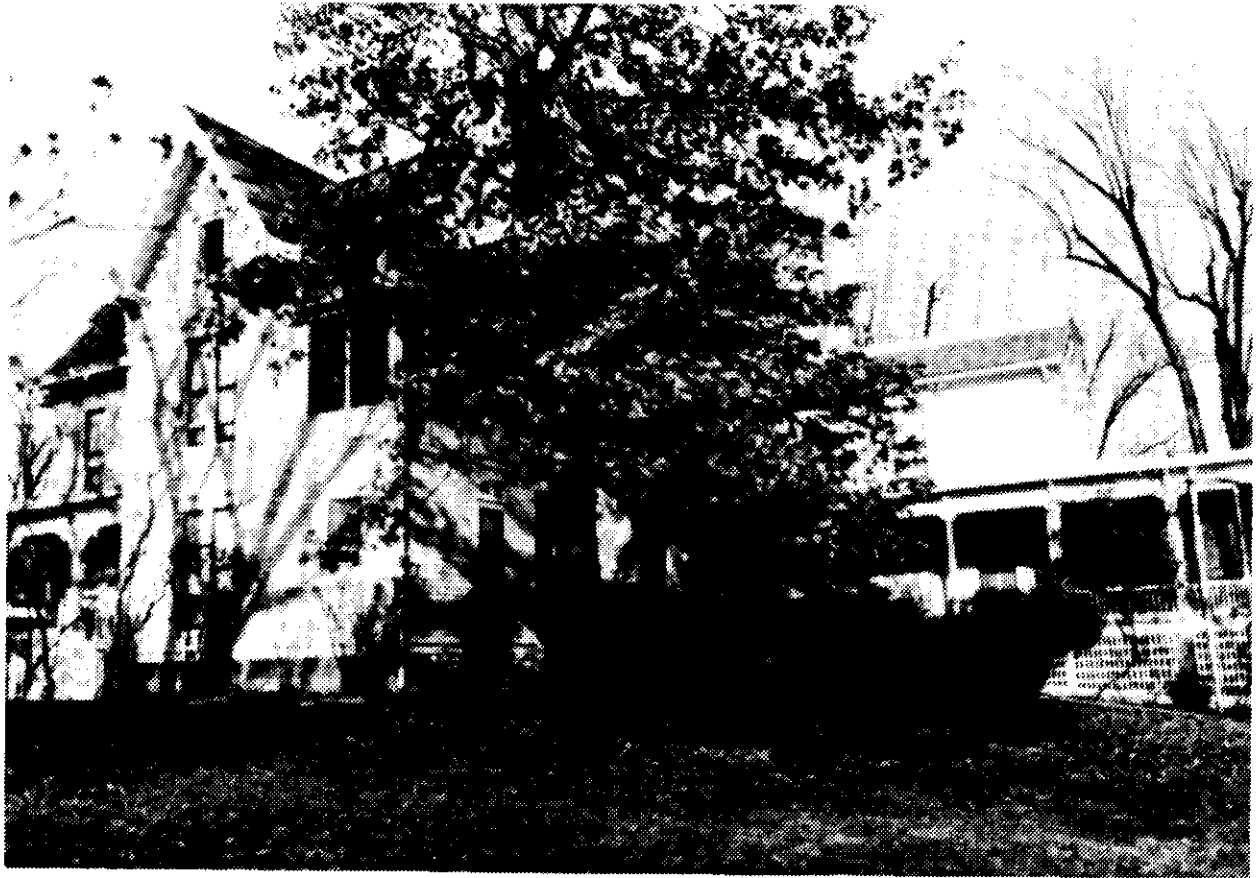
FIGURE 22

Truman home and south yard (looking northwest).

Important landscape features: height of vegetation on the south facade; tree and spirea clump near "L" of house; grapevine; and open lawn space.
